**DAMAGE ASSESSMENT
SITE 44HT45**

**Langley Research Center
Hampton, Virginia**

DAMAGE ASSESSMENT
Site 44HT45
December 2, 2004

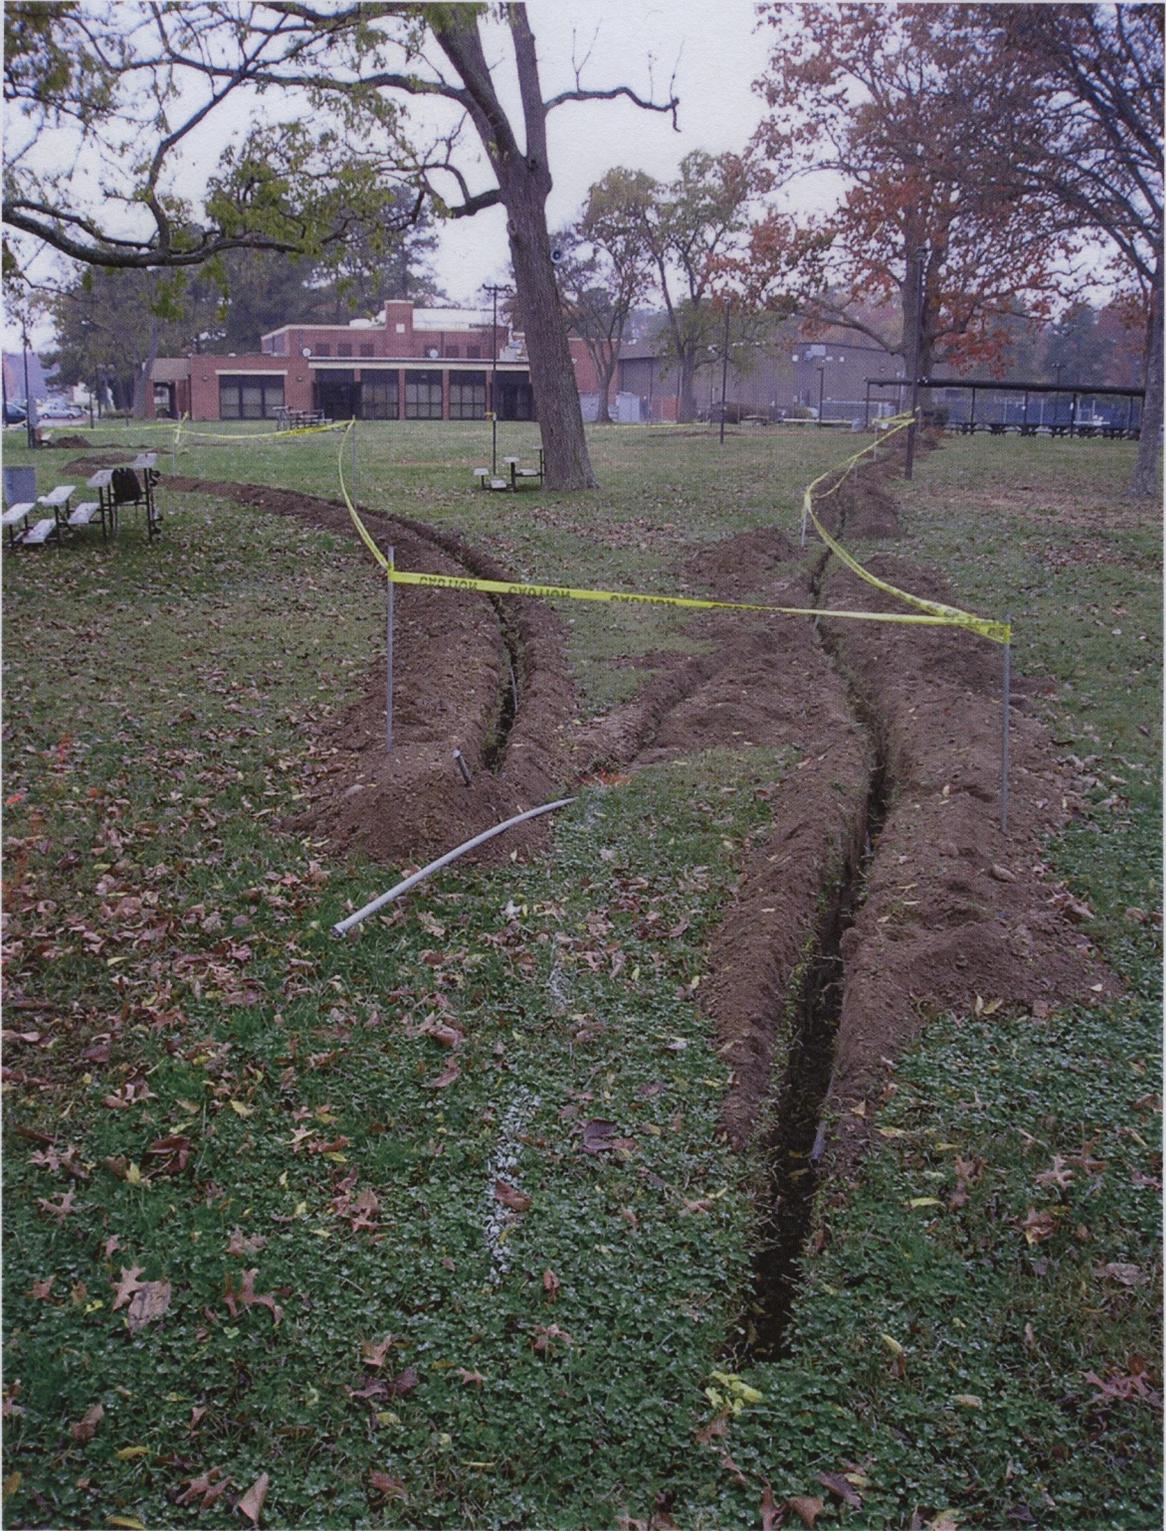
A series of three narrow trenches had been excavated by a ditch-witch machine. The trenches were approximately 7" wide and in most areas to a depth of approximately 25" below the ground surface. The trenches formed a rough triangle shape that extended from a utility pole to a covered barbeque area and near a second utility box near a picnic shelter. In total, roughly 400' to 450' of trench was excavated across the high ground within the site boundaries (Plates 1 through 7).

Plate 1. Overall view of trenches.

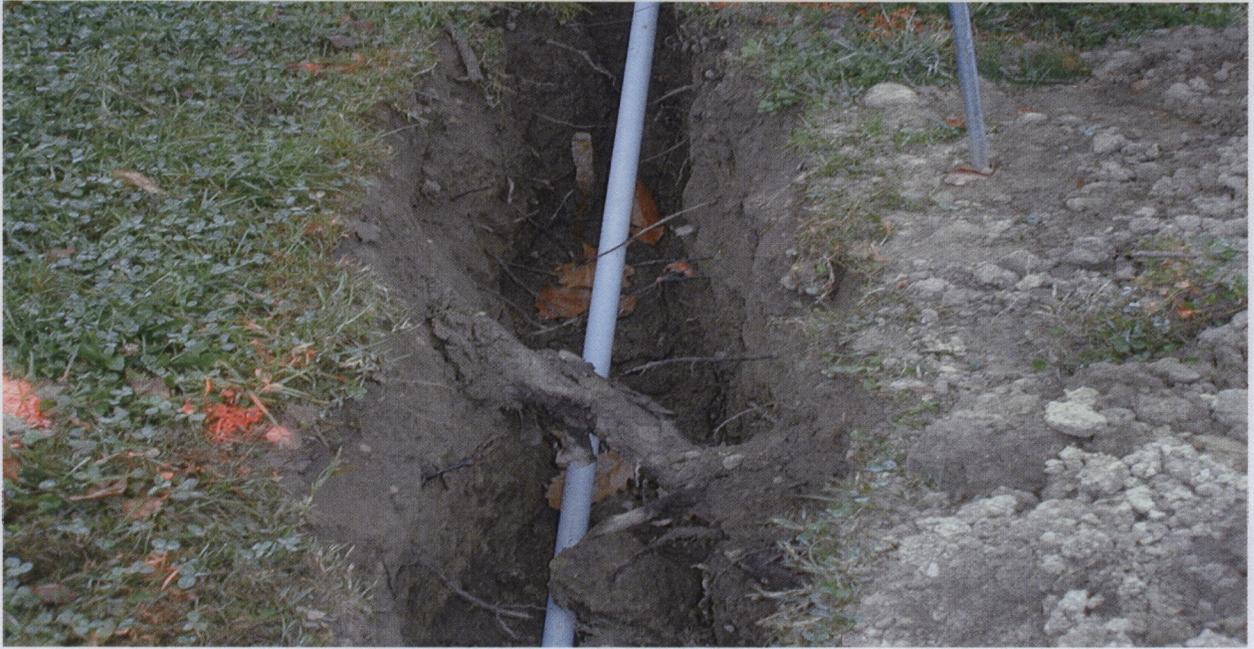
Plate 2. View of trench with pipe.

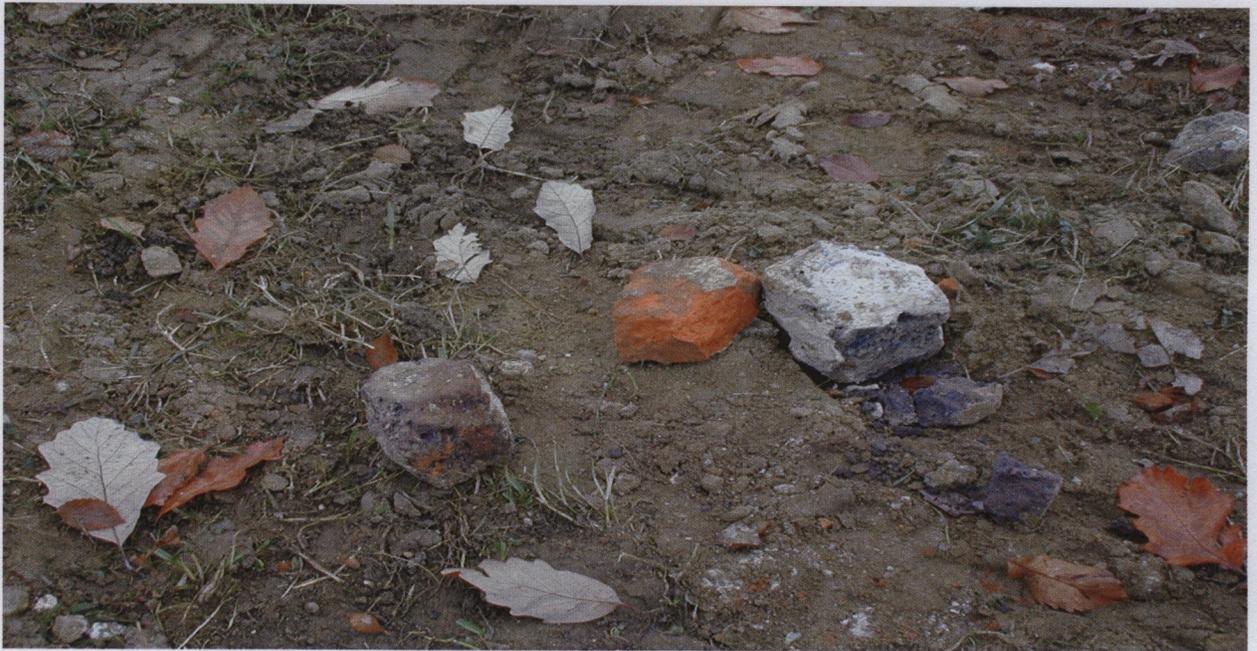
An examination of the sidewalls of the trench indicates that the site has a 12" to 15" thick layer of topsoil and plowzone. In some cases it appears as if the trench may have cut through a brick foundation and a trash pit. Unfortunately, the brick foundation ran the length of the trench and when the ditch-witch blade impacted the brick, the contractor took a pick ax and pulled up the foundation. The foundation wall was approximately 8 to 10 feet long and ended at a T at a possible 18th century foundation. The foundation is made of handmade brick with sand mortar and probably dates to the nineteenth century. This foundation may be an interior wall for the 19th century addition to Cloverdale. JRIA excavated the ditch by hand to see if the subsoil revealed any traces of a builder's trench. The trench was backfilled with brick rubble and this was removed to see the subsoil. No builder's trench was evident as it appeared that the contractor had excavated underneath the foundation into the subsoil when they were pulling it up. At the southern end of the trench a portion of the foundation was partially intact.

Plate 3. View of brick foundation scatter.

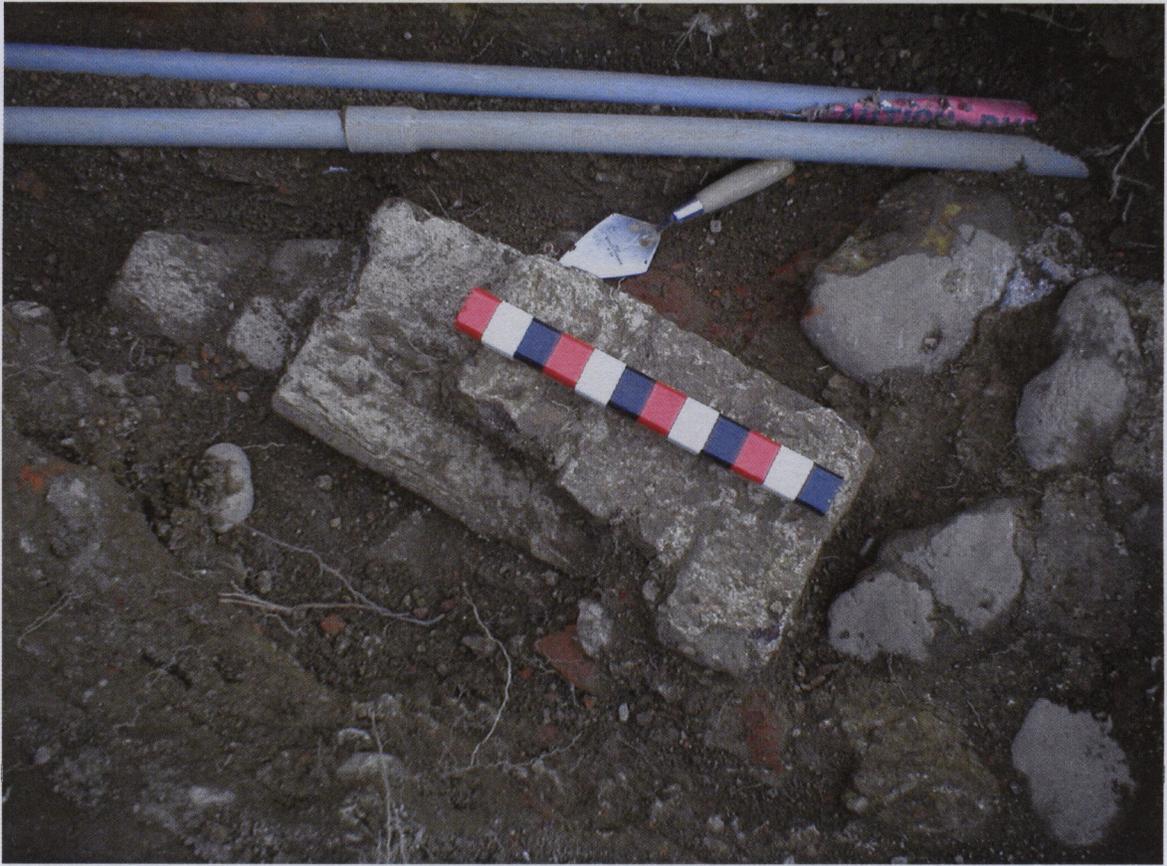
With the exception of the brick foundation, given the 7" width of the trench, the impact to any other potential features appears to be minimal. For instance, it does not appear as if the trenching has completely destroyed any features. Although the damage to the brick foundation is unfortunate, it has not destroyed the integrity of the foundation as a whole.

Plate 4. View of intact brick foundation.

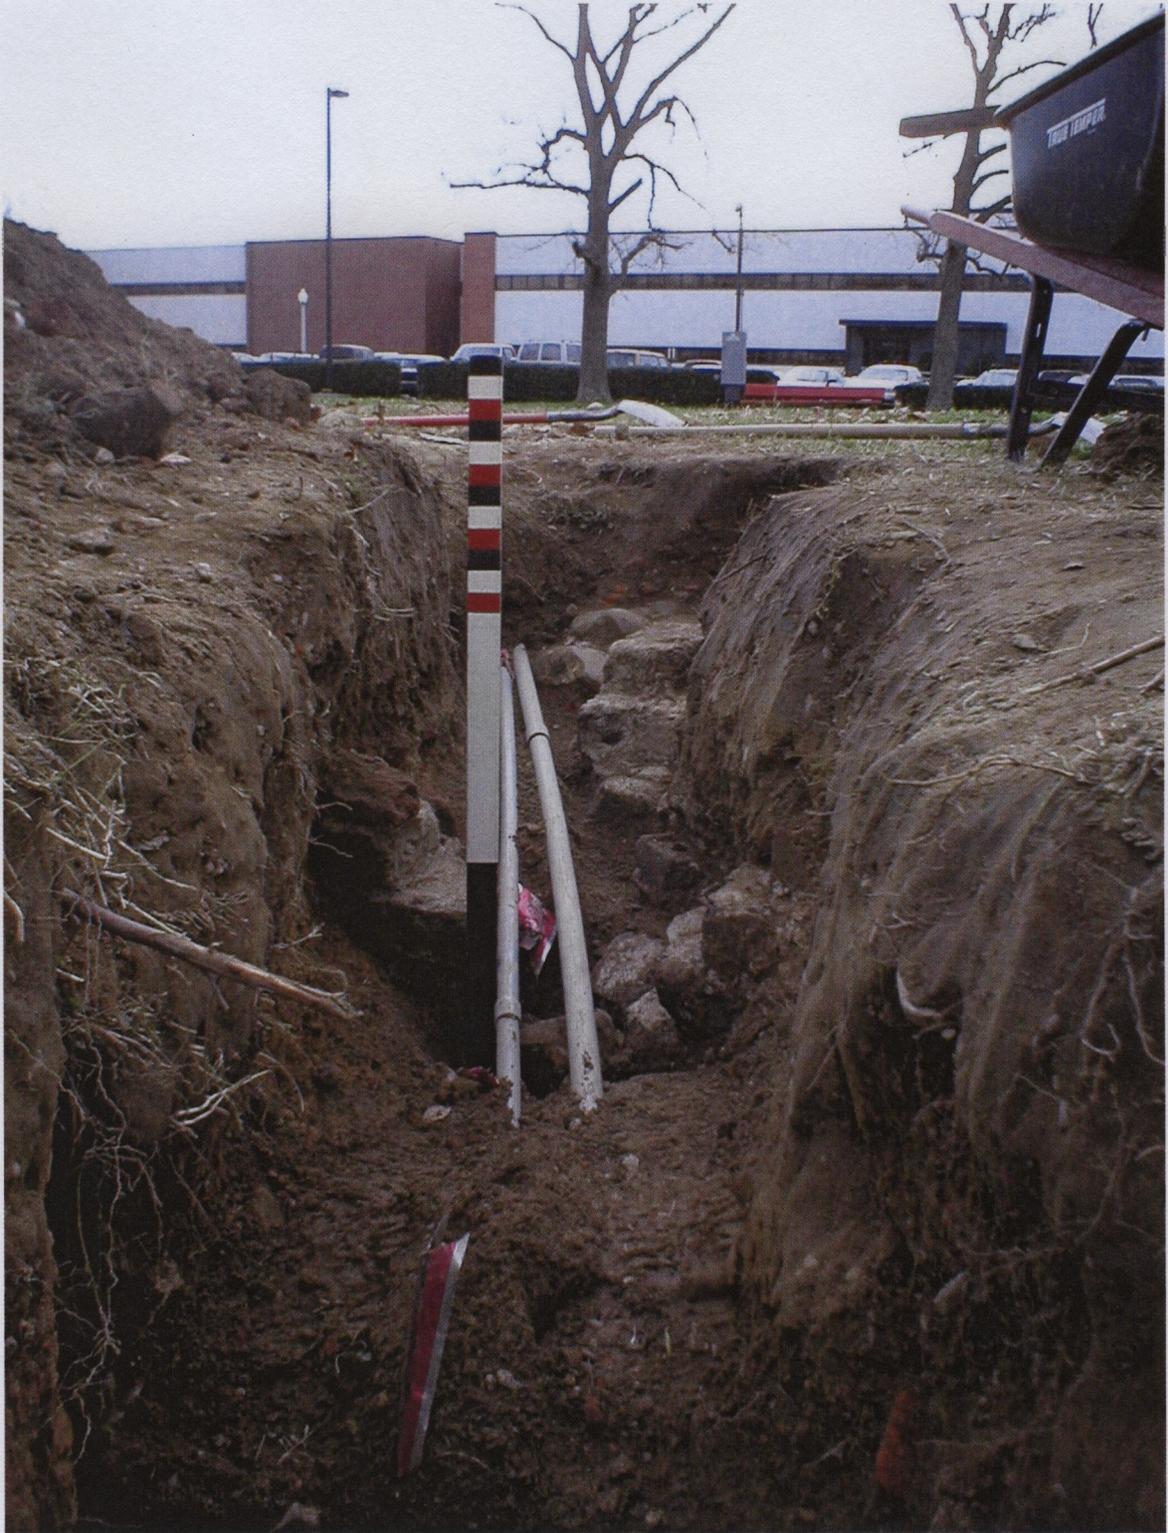
Plate 5. View of brick foundation at base of trench.

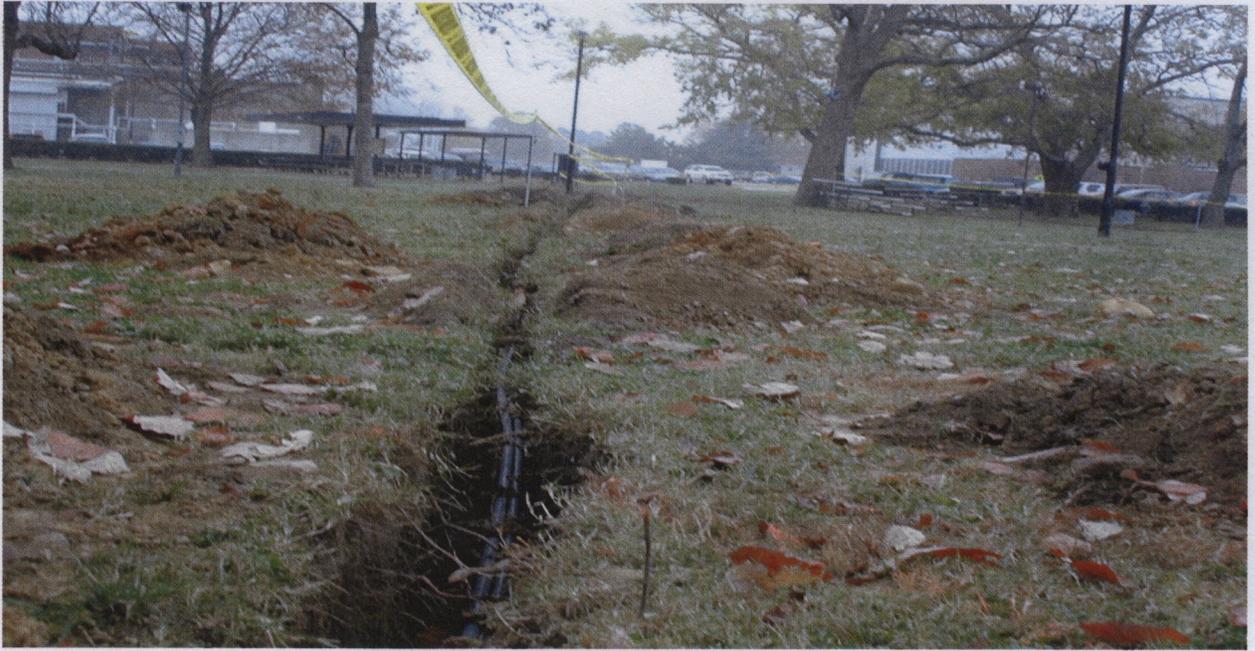
Plate 6. View of trenches, trash pit in foreground.
