Langley Research Center
Hampton, Virginia
23665

MEMORANDUM

SUBJECT: Results of Stress Coat Tests on the 8' TPT Blade Boxes

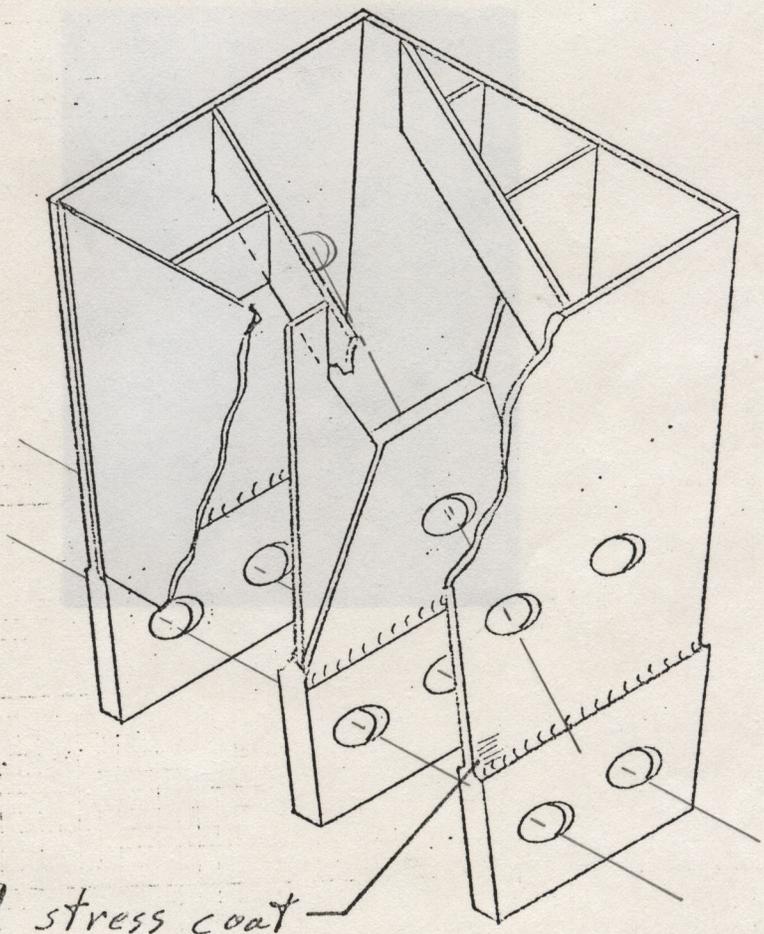
Blade Box No. 2

5. Attachment 1 shows the areas where the stress coat cracked on the boxes. Three general areas cracked. A description of the cracked areas follows:
- (a) Boxes No. 2, 16, and 18 developed stress coat cracks near the outer edges of the side plates. No fatigue cracks have been found in these areas of the side plates.
 - (b) Boxes No. 16 and 18 developed stress coat cracks near the pin hole in the center plate. Numerous cracks have developed in these pin holes.
 - (c) Boxes No. 16 and 18 developed stress coat cracks in the transition radius on the center plate. No fatigue cracks have ever been found in this transition radius.
 - (d) Box No. 32 developed no stress coat cracks. Attachment 2 indicates this box has never developed fatigue cracks.

Area of fractured stress coat

strain required to fracture stress coat - ≈ 1000 $\mu\text{in./in.}$

- (1) Each June, the side plates on all boxes shall be inspected using magnetic particle techniques. This inspection does not require removal of the boxes from the TPT.
- (2) Each November, all boxes shall be completely inspected using magnetic particle techniques. This inspection requires removal of the boxes from the TPT and shall be performed during the yearly maintenance shutdown.

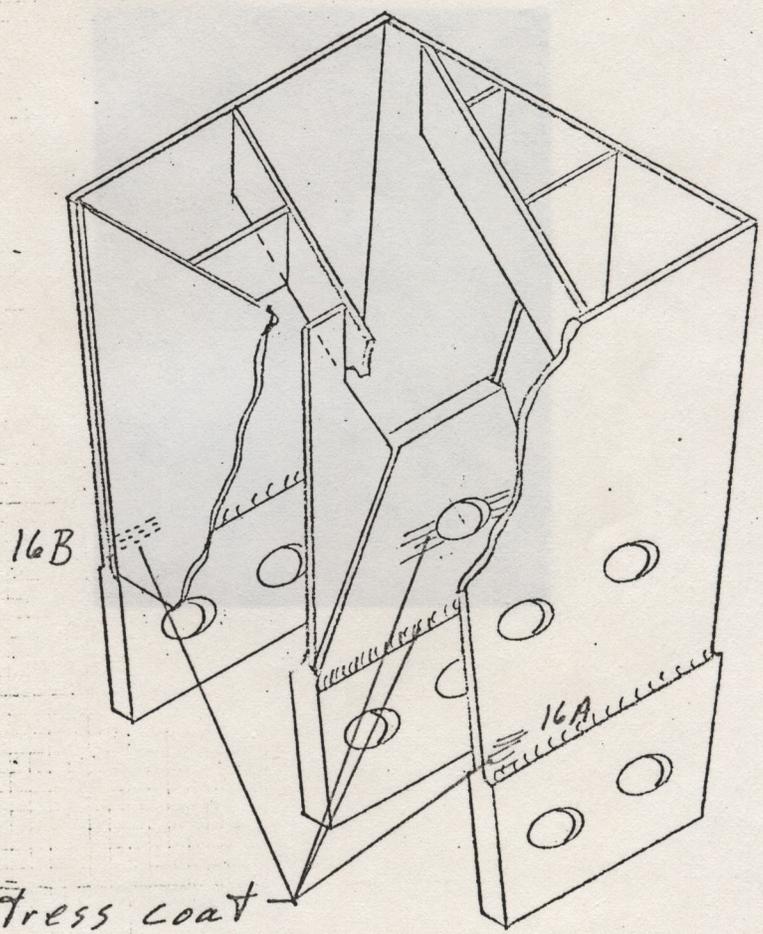
Blade Box No. 16

Areas of fractured stress coat

Strain required to fracture stress coat - $\approx 1000 \mu\text{in/in}$.

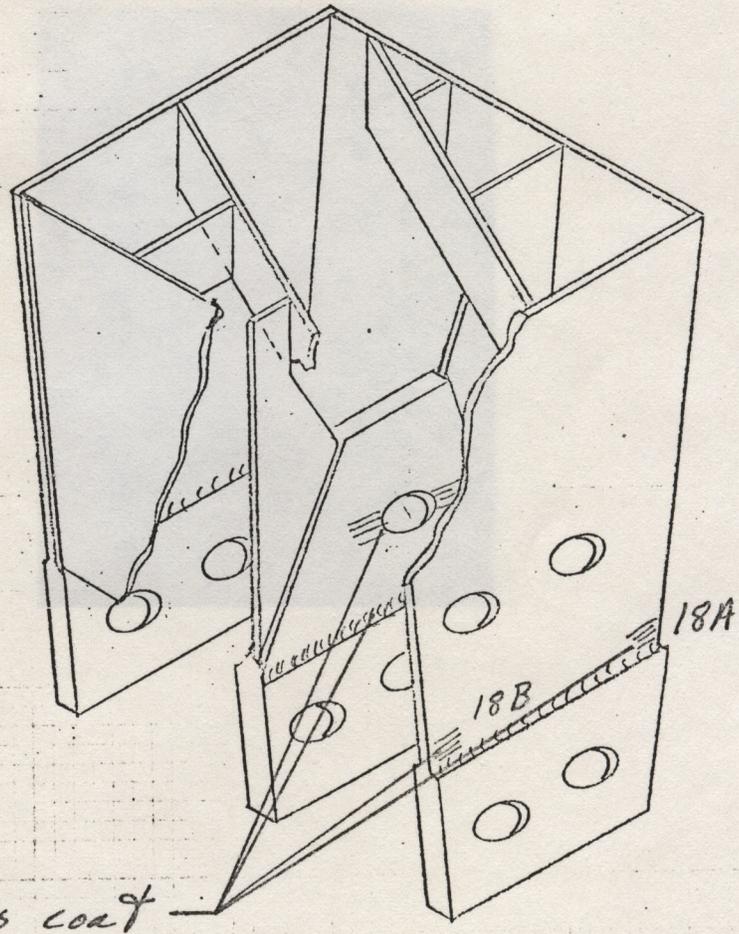
Blade Box No. 18.

Areas of fractured stress coat

strain required to fracture stress coat - ≈ 1000 $\mu\text{in/in}$.

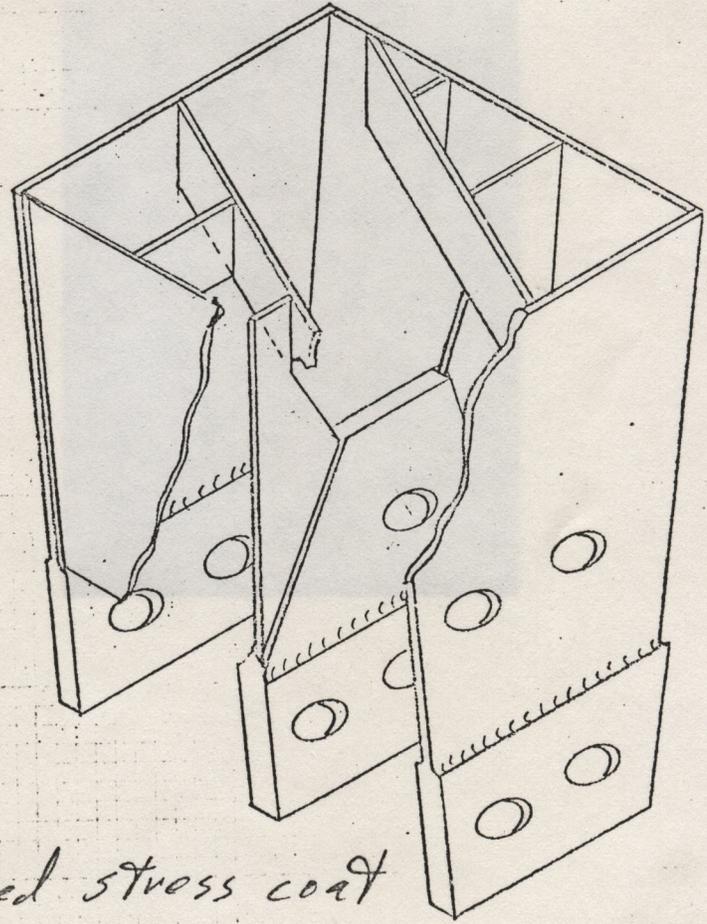
Blade Box No. 32

No areas of fractured stress coat

Strain required to fracture stress coat. - $\sim 1000 \mu\text{in./in.}$

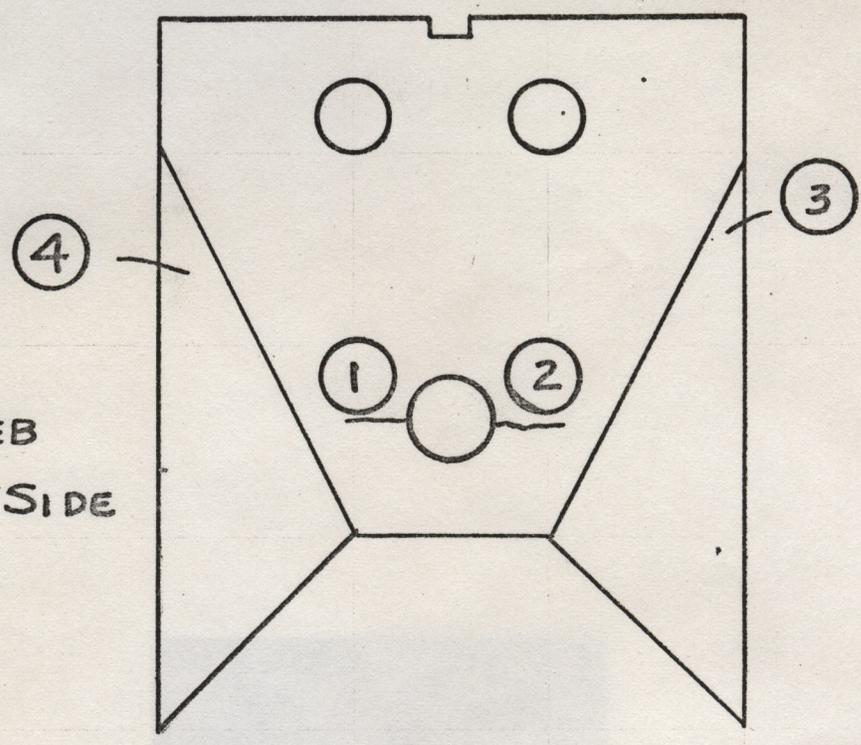
CENTER WEB
UPSTREAM SIDE

SEE SHEET 2 FOR CRACK LOCATION ON
EACH BLADE BOX
